**DESCRIPTION OF CURRENT CONDITIONS
U.S. STEEL FAIRLESS WORKS**

U.S. STEEL

**JULY 1993
REVISED MARCH 1994**

BCM PROJECT NO. 00-5039-70

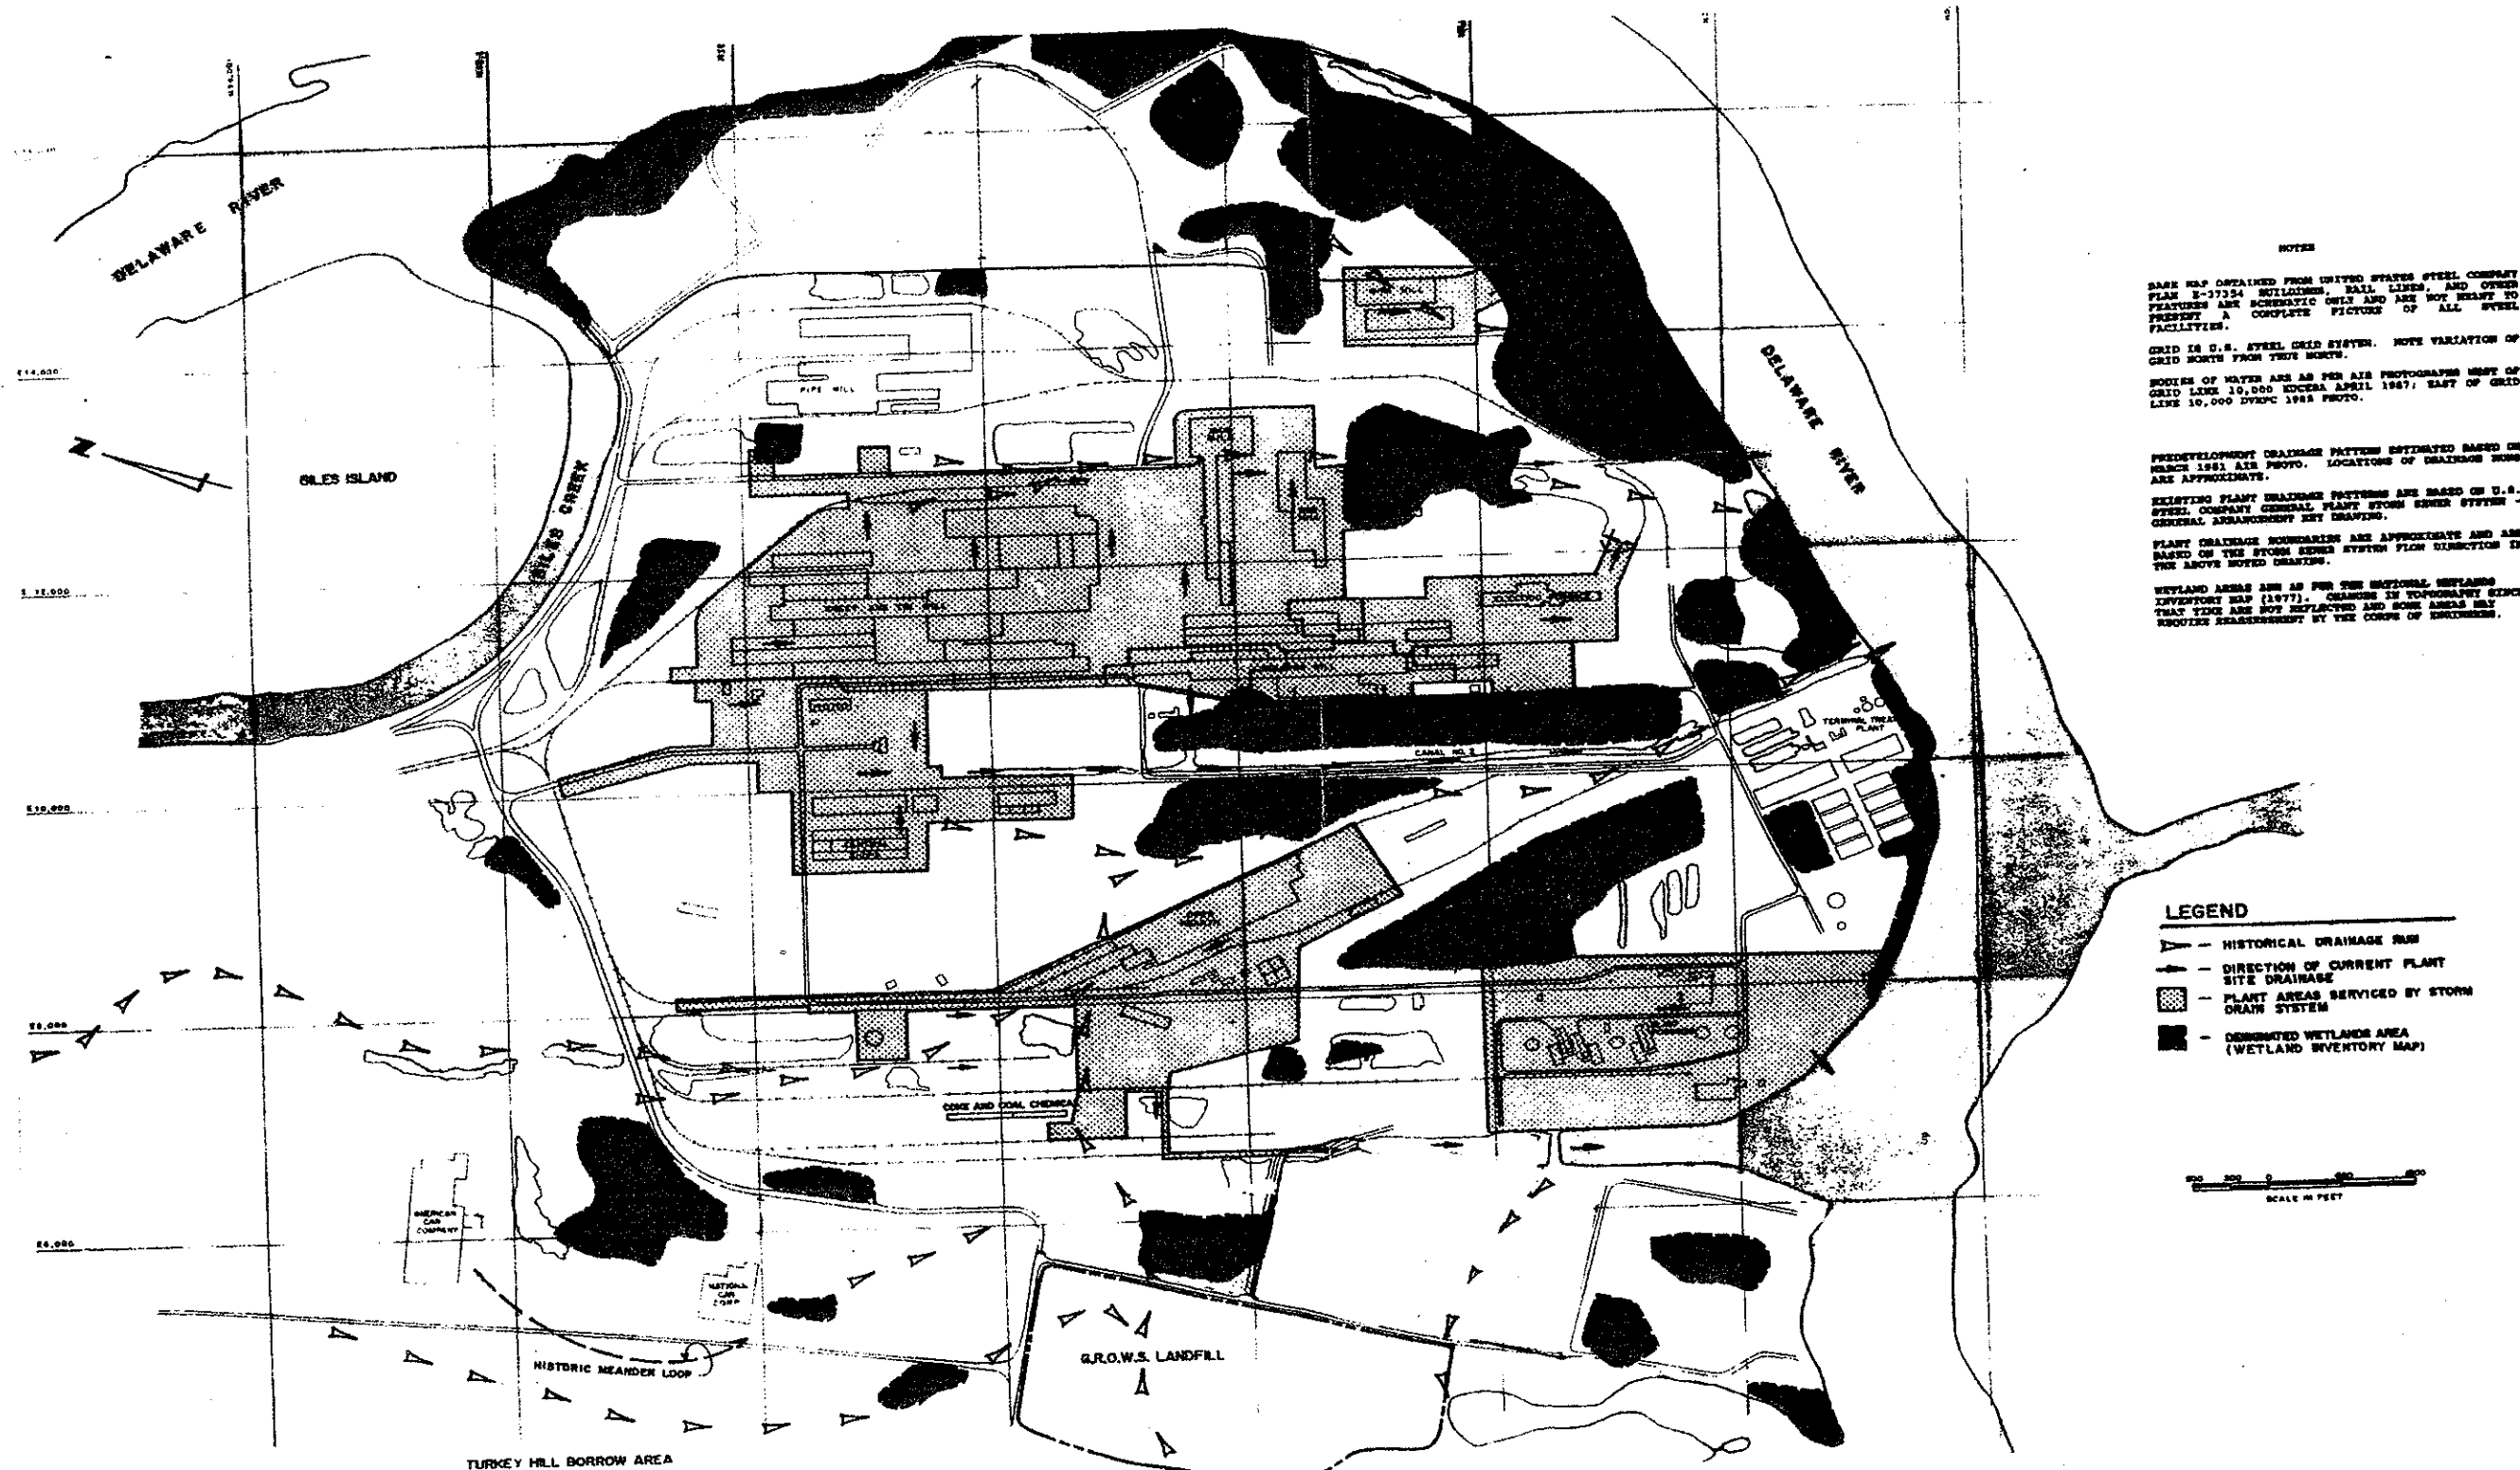
Figure 7

Surface Hydrology and Wetland Areas, Fairless Works

The three canals onsite receive permitted NPDES discharges of noncontact cooling water, sanitary effluent, and storm water runoff from the facility. Tidal effects are noted in the canals but differ with locations. The East Canal, below the NPDES monitoring point, is affected by tides but the area upstream of the monitoring point is not affected. The central Canal is tidal to a significant distance upstream from the point of discharge to the river. The West Canal, emptying into the boat slip, only receives storm water runoff. The effects of the tides in the West Canal are unknown. Although observations indicate tidally induced flow in portions of the canals, no data are available to quantify this condition. The locations of the canals are shown on the topographic map as well as Plate 3, Storm Sewer System.
